Title: LA-43-S-CT Post Shot

LA-43-S-CT Post Shot

Abstract

LA-43-S-CT was conducted on 12/14/15 to verify the performance of the HE/Armature system intended for use in a new configuration of Ranchero Flux Compression Generators (FCGs). Subsystem tests preceded this experiment, and a synopsis of the issues explored in these is presented. The system was viewed by two fast framing cameras, an array of PDV probes, and an electronic streak camera that provide very good time and space resolution for motion of the armature during expansion. The test is described in very good detail, and the result is that the armature system is adequate for use in the Ranchero 43-S system for future physics tests.

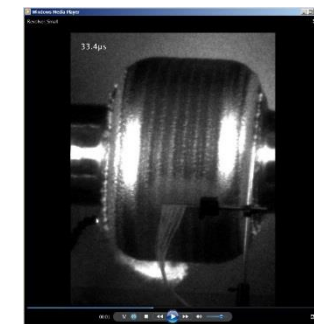
Ranchero Armature with PBX-9501, without smoother; 2X expansion. LA-19.4-CT-2; 9/13. Armature good condition; surface better where buffed to make PDV signals better.

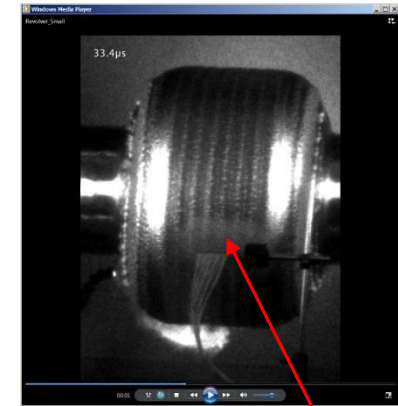
"Buffing"

LA-19.5 CT-3 Showed that 9501 would not destroy armature (LA-UR-14-28810)

- PBX-9501 does not break up the 6 mm thick annealed 6061 Al armature
- Gaps as big as .005" and the seam caused by the edge of a .005" Mylar shim do not show up (don't cause a problem). We will still strive for the best possible fit.

- Armature velocity is 3.8 mm/ μ s, as compared to 3.3 mm/ μ s for PBXN-110 without smoother and 3.1 mm/ μ s for PBXN-110 with a smoother. The time to travel 76.2 mm from first motion is less than $\sim 22 \mu$ s for this test, as compared to $\sim 25 \mu$ s for LA-43-CT-2. This time difference was not carefully measured on LA-43-CT-1, but it will be even larger on that test.

- Breakout patterns measured with PDV probes show that ripple due to detonator spacing is small compared to detonator jitter.
- PDV probes show that the armature spalls, then recollects.

- Recollection times do correlate to detonator position, the recollection being earlier above dets, and later in between them.
- The "buffing" performed to facilitate good PDV signals is likely a good practice for FCG armatures, as the camera results seem to show less "fluff" leading the armature in the buffed area.

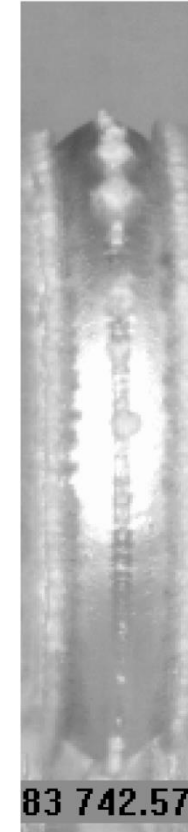
To build a Ranchero Armature with PBX 9501, machined pieces have to be glued together. Small scale tests reported in LA-UR-15-23837 were conducted to determine if acceptable glue joints could be made. The tests shown here demonstrated that the shock wave interaction between two initiation pellets must not be allowed to run down a glue joint

- The baseline HE design for Ranchero assemblies had a glue joint exactly half way between two slapper detonator points, and some calculations showed the armature rupturing adjacent to the joint (some did not).

- All calculations with the glue joint offset by 3 mm from the center showed that the gap would not rupture
- 30 mm thick, 155 mm diameter PBX 9501 charges were detonated in counterbores which spaced the detonators 18 mm apart.

- One control test was fired with no seam in the explosive ("Solid" in the figure to the right)
- One test was conducted with the glue joint halfway between the detonators ("symmetric") in the figure to the right.

- One test was conducted with the glue joint offset 3 mm from the symmetric point.
- The "solid" test shows the shockwave interaction, but does not rupture

- The "Symmetric" test shows significant rupturing
- The Offset shot shows the shock wave interaction, but no rupture along the glue joint.

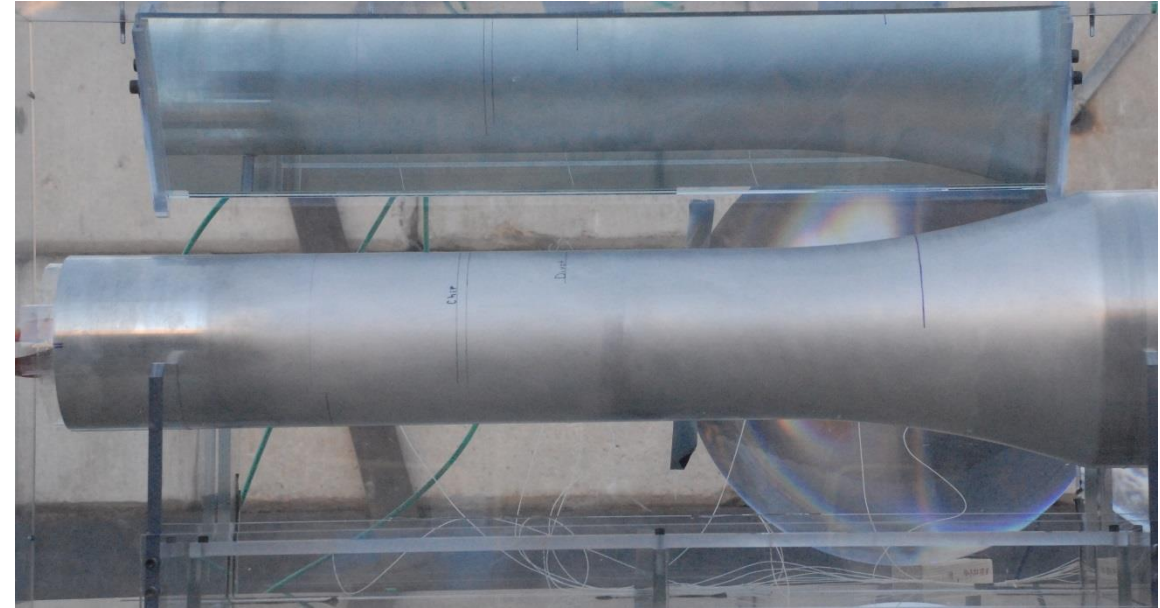
Shot enclosure provides a helium atmosphere that prevents an air shock from obscuring the surface during expansion. Mirror in shot enclosure also provides backside coverage for ~2X expansion.

Front wall is thin polycarbonate/ all other walls are ½" polycarbonate

End view of setup showing Polycarbonate box to hold He which prevents an air shock from developing and obscuring the expanding surface.

- Armature was opened up to 10 mils clearance on radius from previous designs with 5 mil clearance
- HE was 5 mil undersize on diameter (not 6.000" but 5.995")
- HE positioned on floor and Armature lowered over it.
- 5 mil Mylar shim inserted all the way around, then 5 mils more at 4 sides.
- Armature lifted, then inverted so HE slid to position justifying it on angle of swoop.
- 5 mil feeler gauge inserted on 3 sides, and would not quite go in on fourth.
- Aluminum plate positioned on end with rubber grommets to maintain loading on G-10 disc so that HE was held against the cone.
